Surfactant leaching on newly painted exterior surfaces

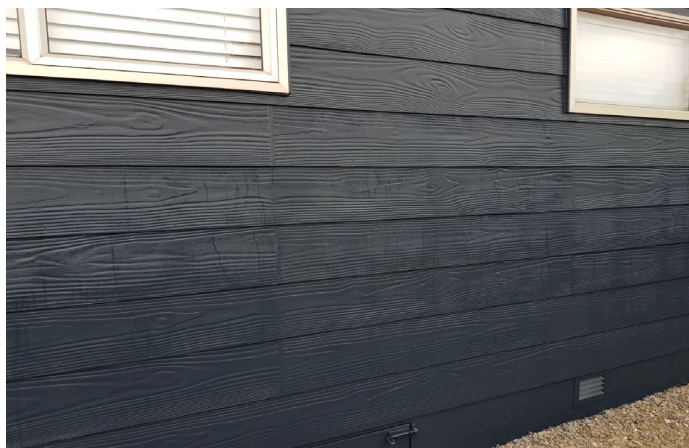
Surfactant leaching is a common occurrence with freshly applied paint coatings. The soapy deposits come to the surface of the paint coating when they are exposed to humid conditions. The leaching takes on the appearance of a clear or tannish colour stain often running down the surface. The staining can be sticky to touch. While it can be found on freshly applied paint coatings of any colour it is especially common on dark colours where large amounts of colourant have been used to deliver the desired colour

This leaching is not a painting workmanship issue and is unlikely to be happening because the painter has done something wrong or has used low quality paint.

Surfactant leaching can become noticeable after only a few days. Once the surfactant is visible it should be washed off with a soft brush and warm water before rinsing with a garden hose to remove the soap lather. The washing down may have to be done on a couple of occasions until all the surfactant is completely released.
