Substrate Fastening Popping

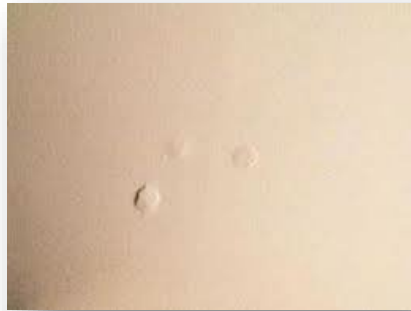
Home owners are often both alarmed and disappointed to see fastener heads popping up in their new plasterboard walls and ceilings. The lumps appearing in the surface can be both extensive and ugly.

It is highly unlikely to be caused by a painting workmanship failure, the paint coating or anything else the painting contractor may or may not have done in the painting process of the substrate. As long as the plasterboard has been installed according to the manufacturers recommendations any popping is more than likely related to timber shrinkage.

Popping that occurs after at least one months heating cycle are a good indication that timber shrinkage is the cause.

Should fastening popping be noted to new plasterboard surfaces the home owner should take this up with the building contractor as this is not a painting workmanship fault.
